Secondary air injection malfunction (causal chain)
1	Fault code ( <sup>ÚSÁ)</sup> Display on generic scan tool)	P2003 (P0410)
2	Fault storage	after the end of the test period and faults
	Activation of malfunction indicator lamp for engine diagnosis (EURO3/4) or CHECK ENGINE (MIL)	after two successive driving cycles with faults
3	Frequency of the test	once per driving cycle
4	Checked signal or status	Lambda control
5	Fault setting conditions Test duration	Increase of lambda control factor by at least +23 % ("rich" - stop) approx. 10 s
6	Test prerequisites	- Engine at idle speed - vehicle at rest - air pump activated at least once after engine start - no fault in voltage supply for purge control valve, air pump control valve and electric air pump - no fault in purge - no fault in throttle valve actuator - no combustion misfires - no fault in oxygen sensor upstream of TWC, aging - no fault in CAN data bus - self-adaptation of the mixture formation not at limit - air pressure greater than approx. 780 hPa (i.e. no test is performed above a height of approx. 2500 m) - coolant temperature greater than 50 °C - lambda control enabled - air conditioning off

## Secondary air injection for En

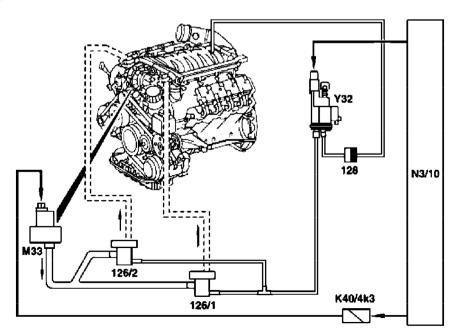
126/1 Shut-off valve for secondary air injection on left (combination valve: check valve integrated)
126/2 Shut-off valve for secondary air injection on right (combination valve: check valve integrated)
128 Check valve (intake manifold vacuum)

K40/4k3 Relay for secondary air injection e.g. Models 208, 210 M33 Electric air pump N3/10 ME-SFI control module Y32 Air pump switchover valve
